THE GREAT ALASKA EARTHQUAKE

Volume II

Illustrations and Maps

TECHNICAL REPORT NO. AFWL-TR-65-92, Vol II

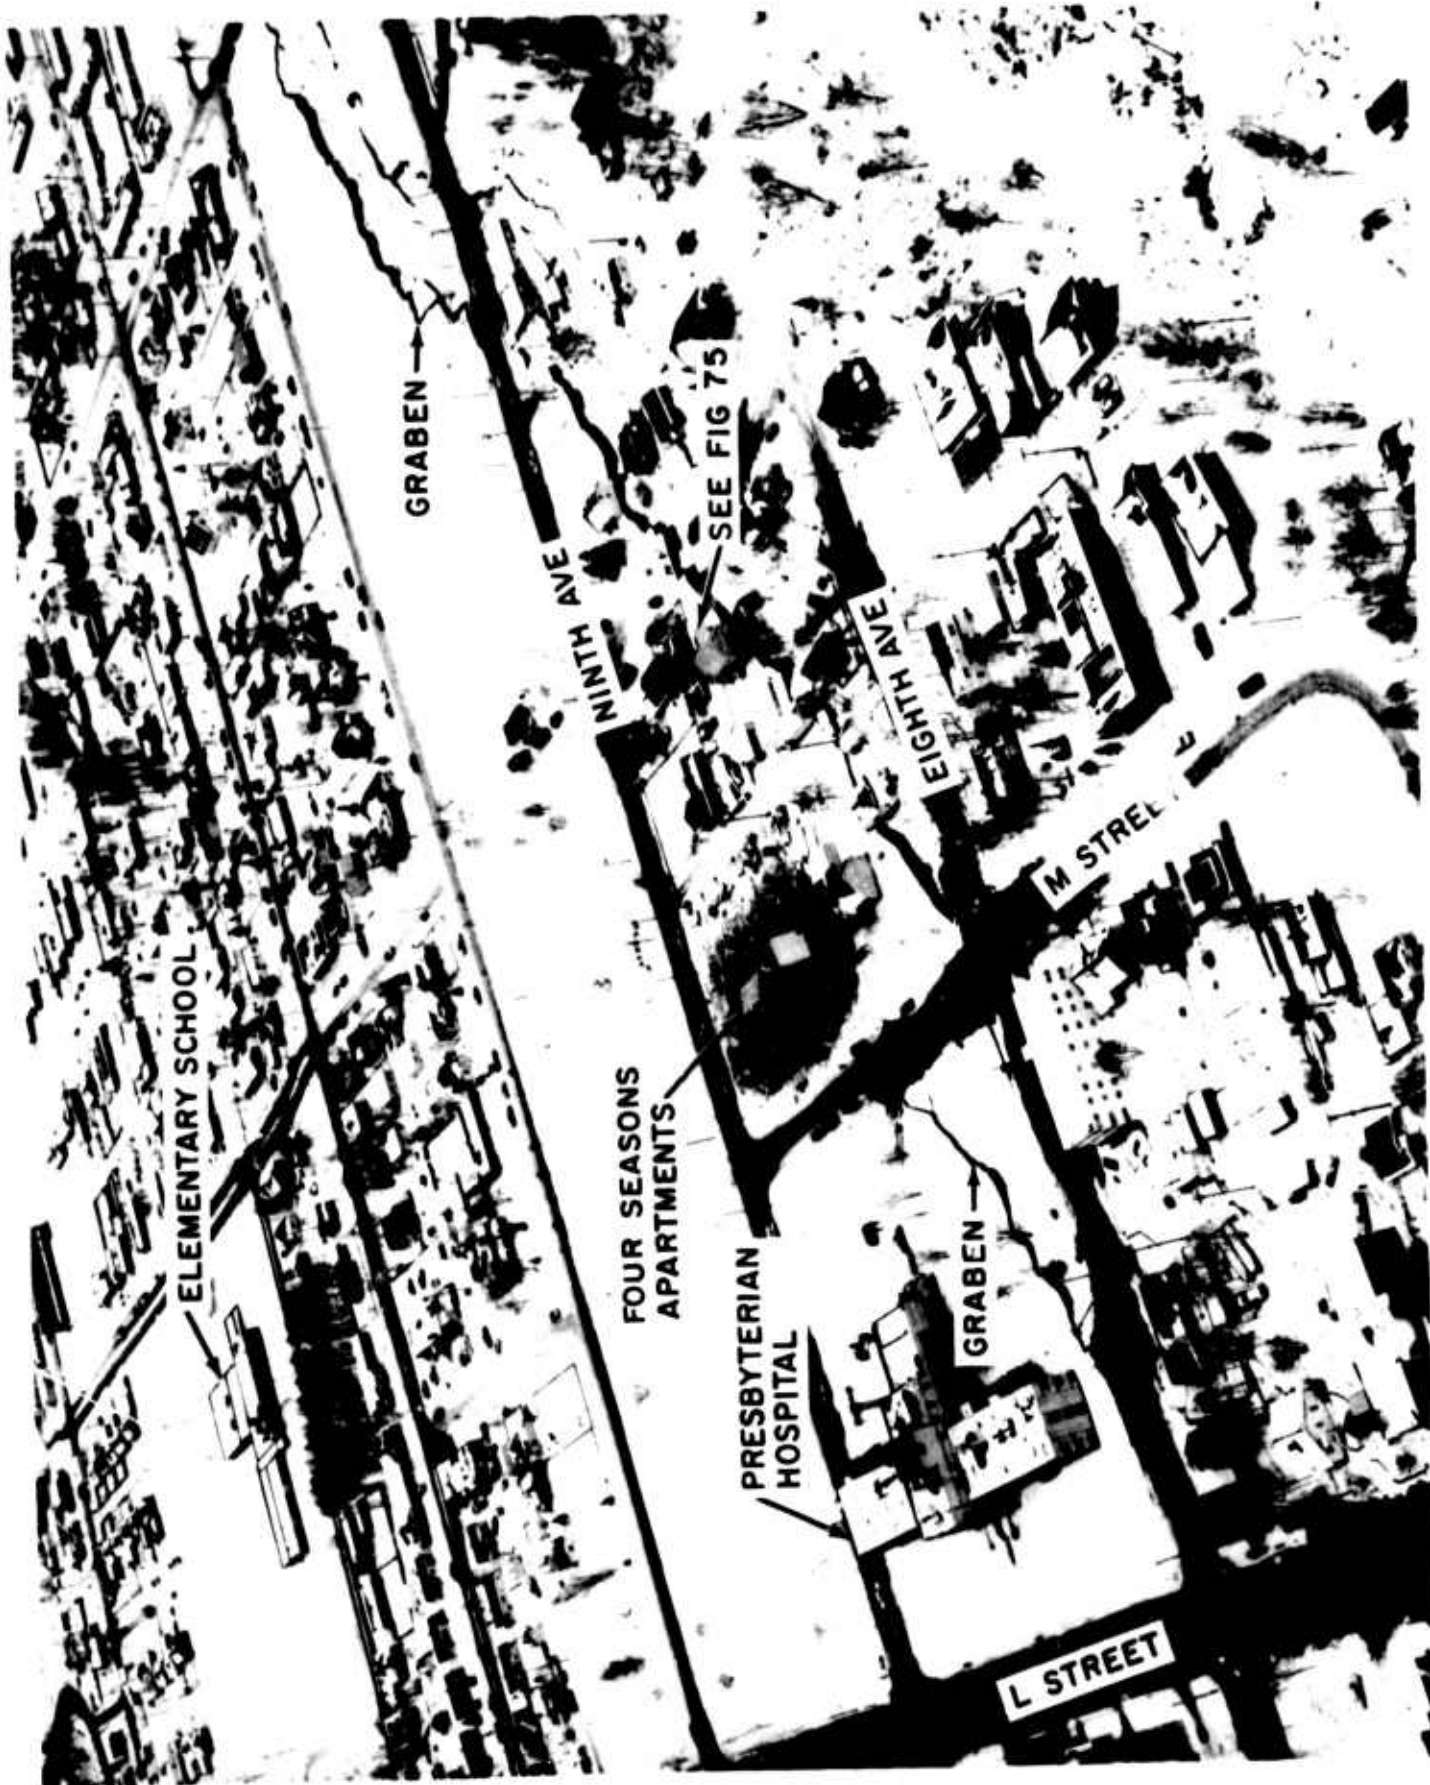
Figure 78. L Street Slide (Four Seasons Apartments)

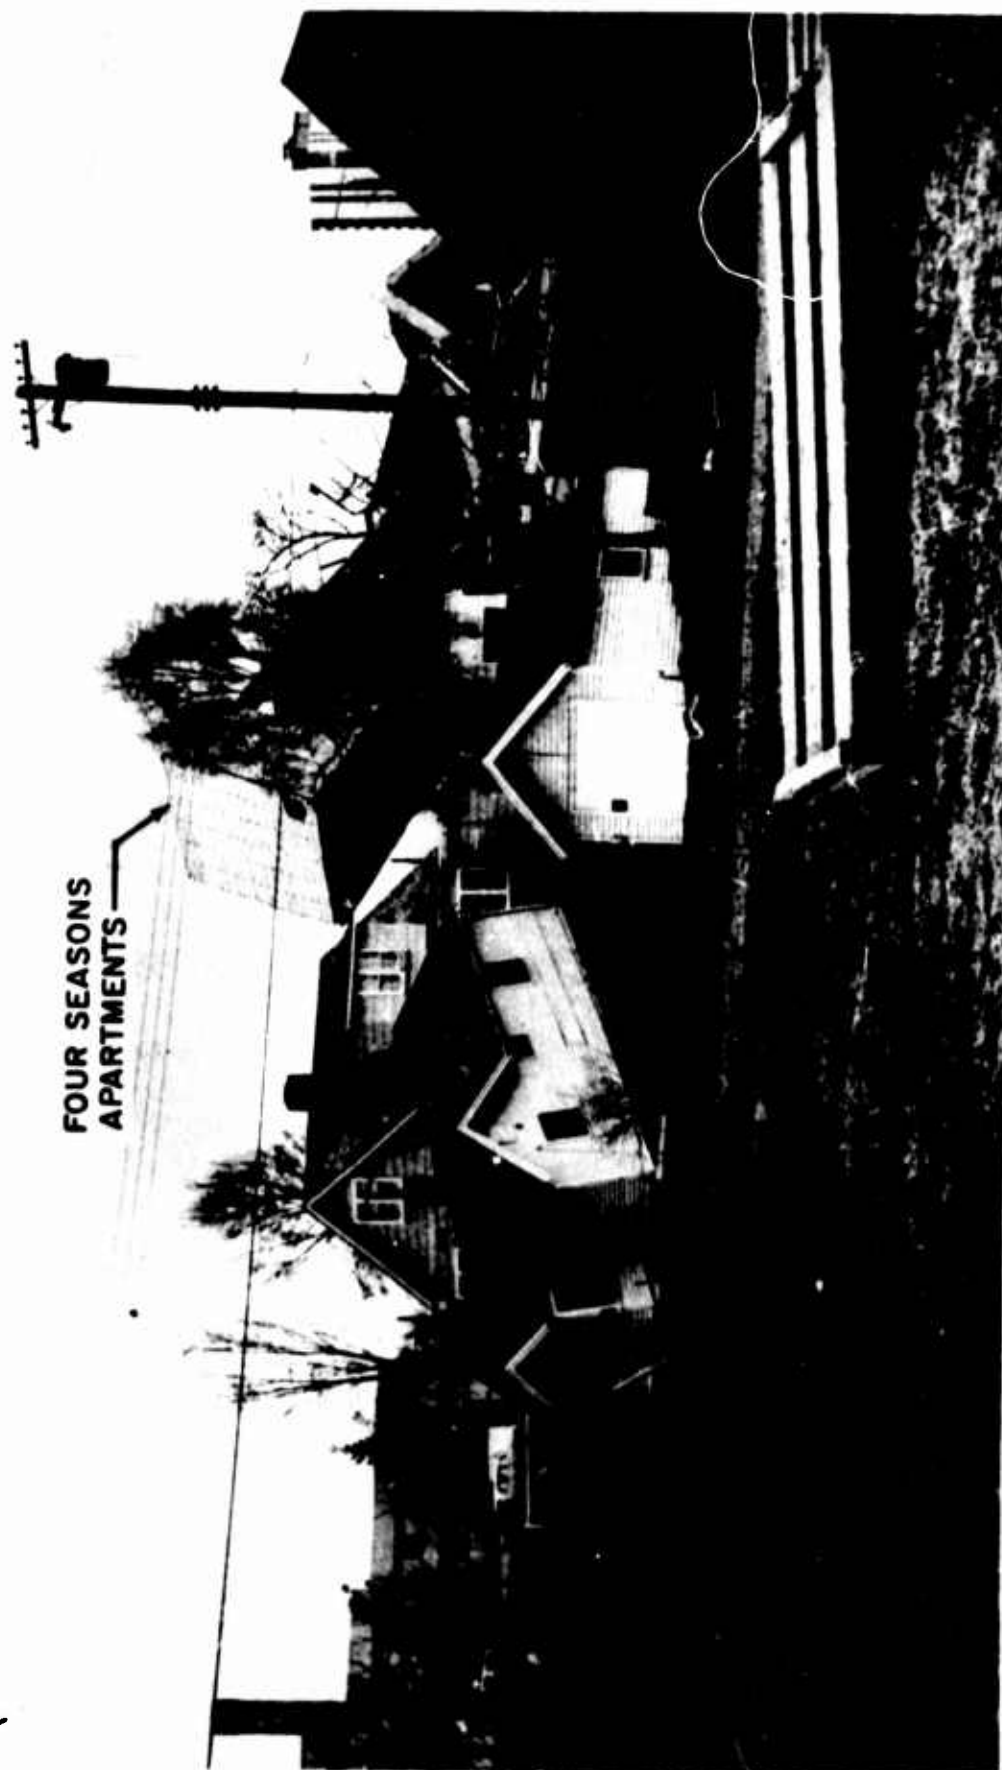
Figure 79. L Street Slide (Residence on Eights Avenue between M and N Streets)

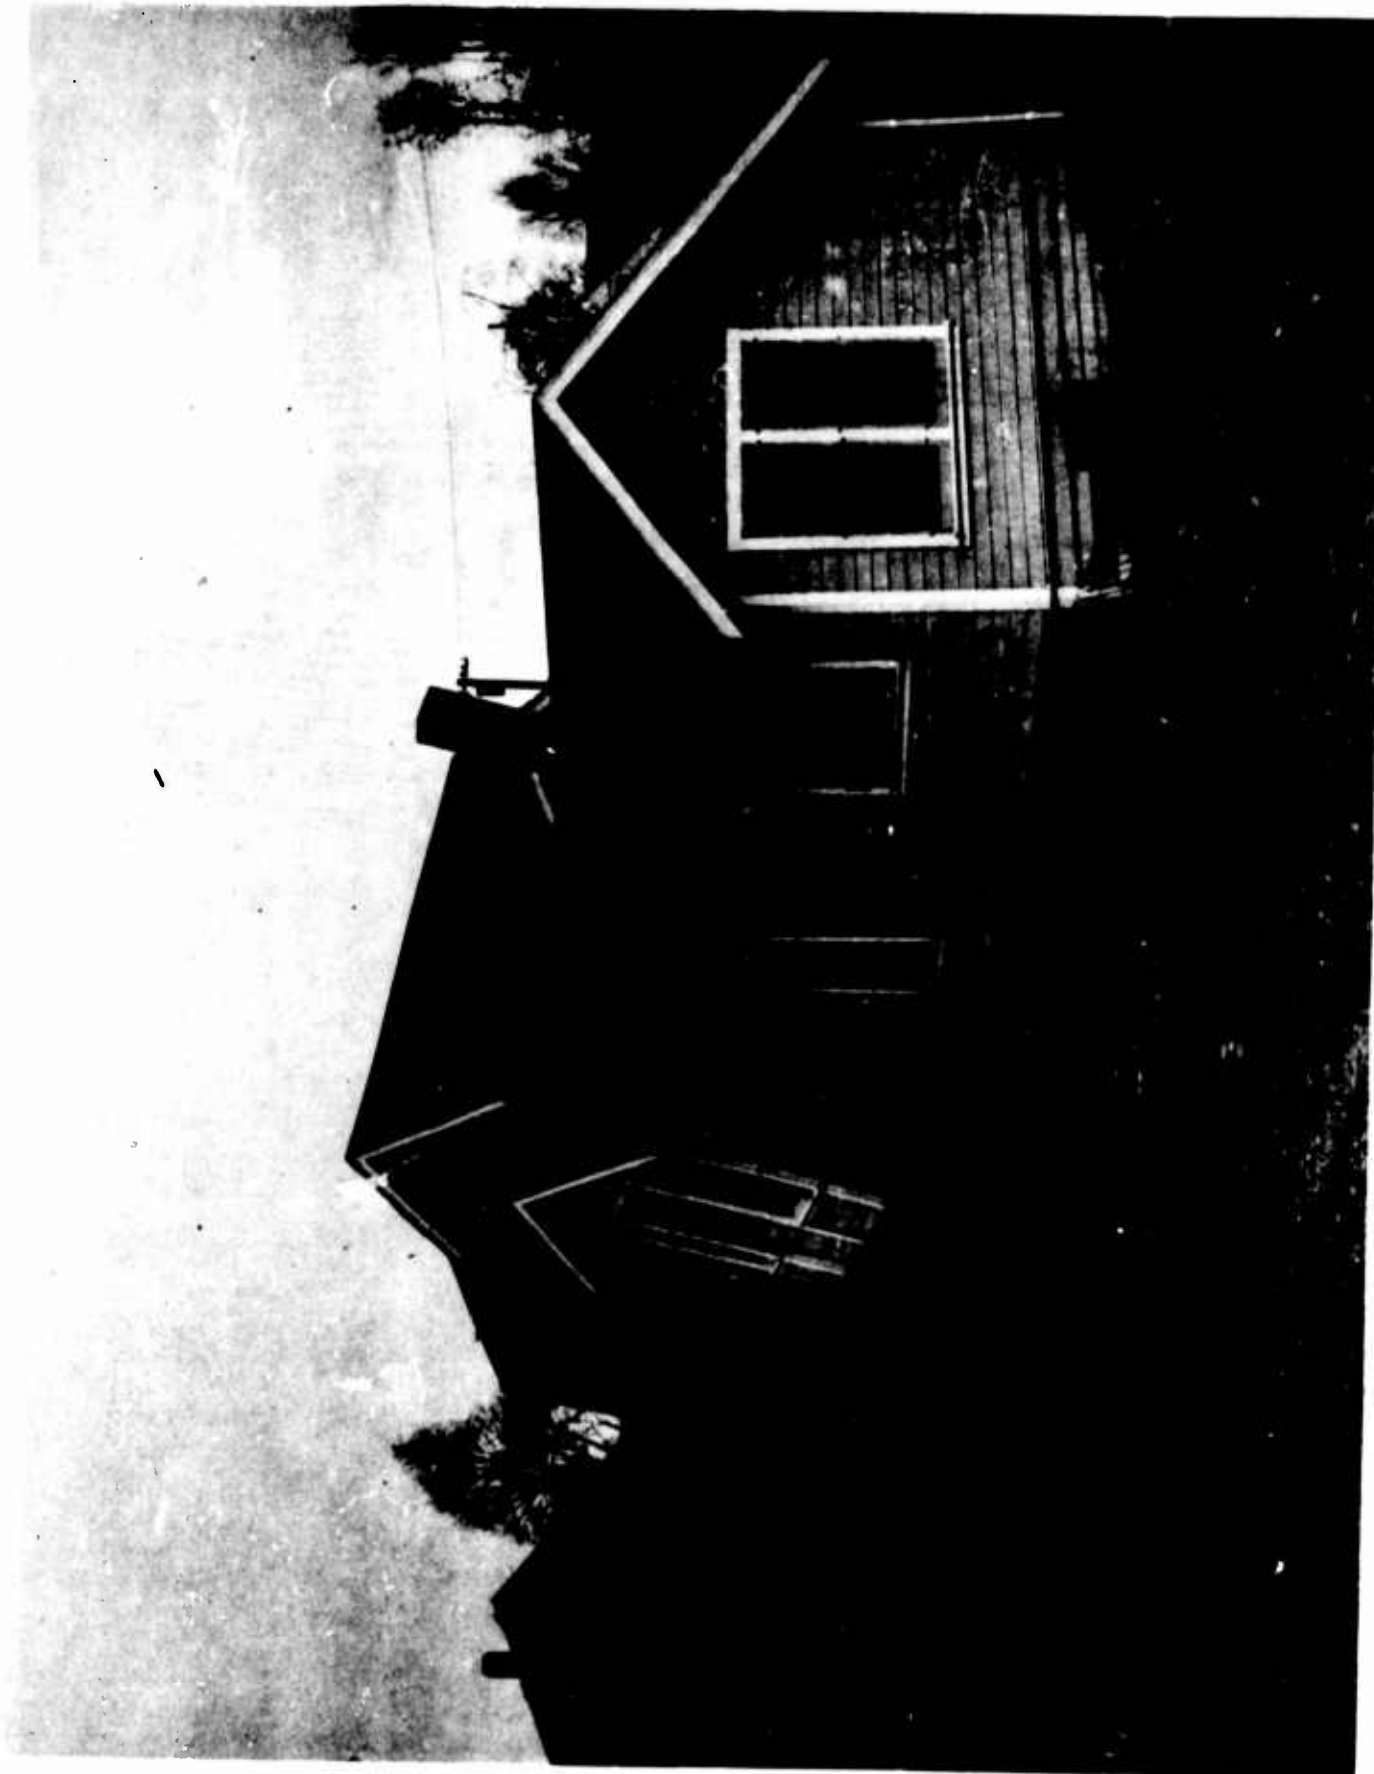
Figure 80. L Street Slide (Residence at Eighth Avenue and N Street)

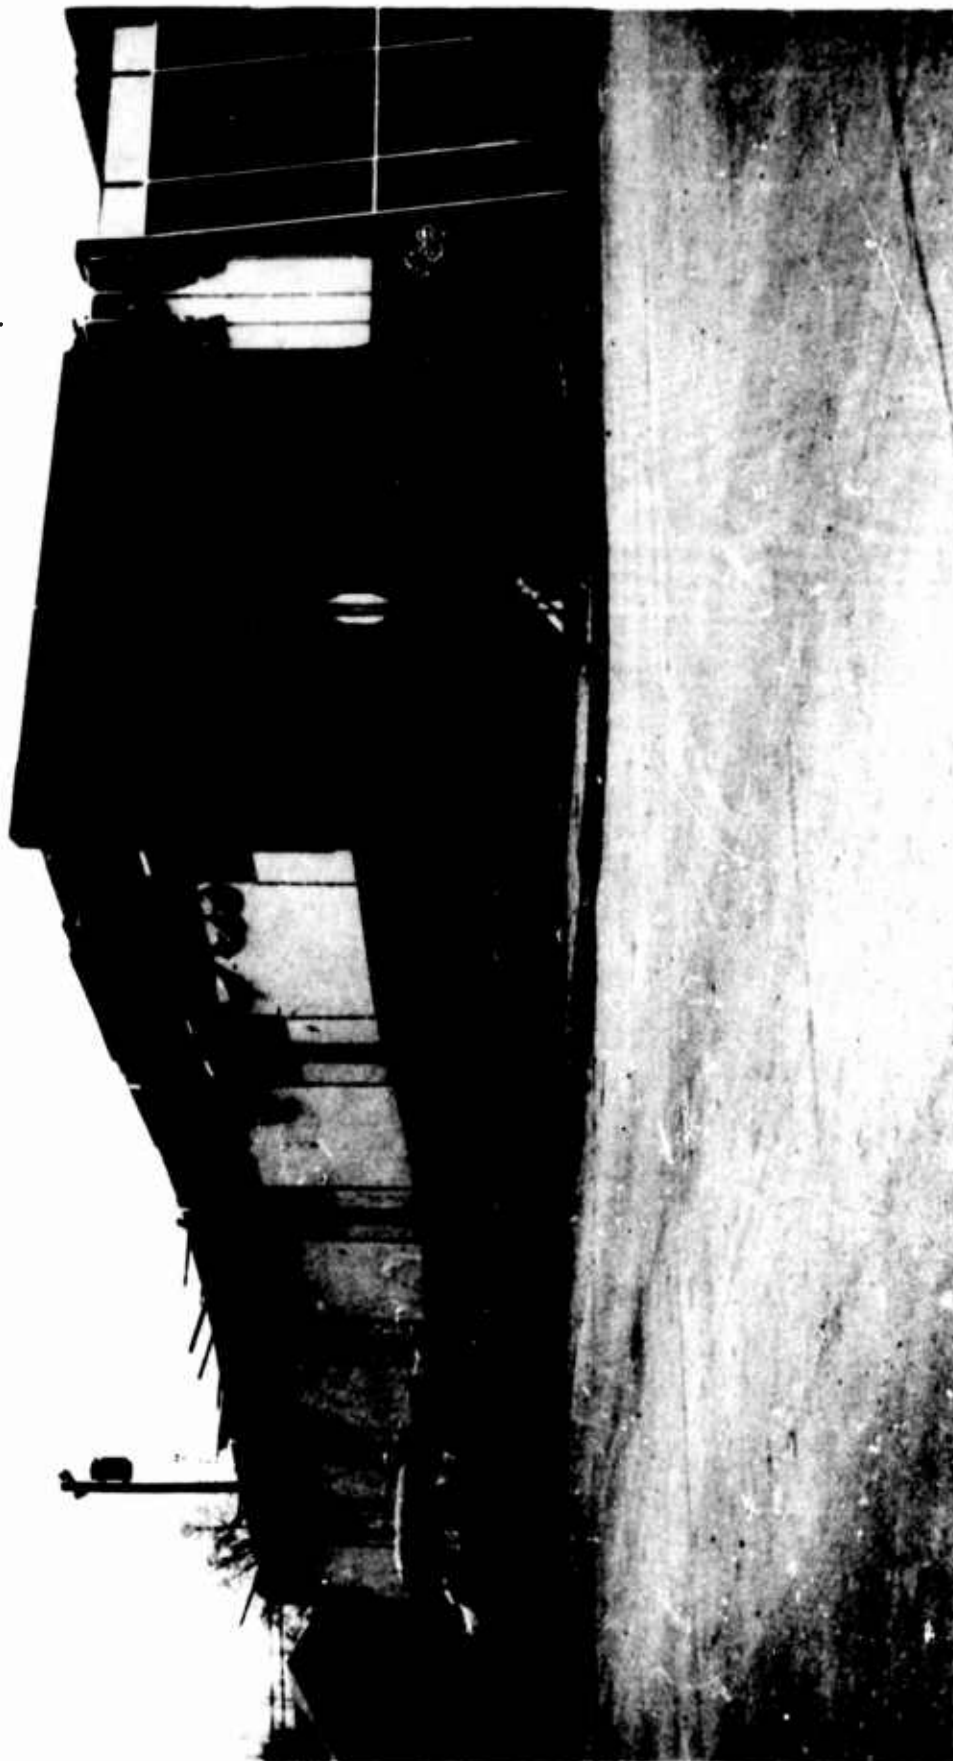
Figure 84. L Street Slide (Commercial building at Sixth Avenue and K Street)

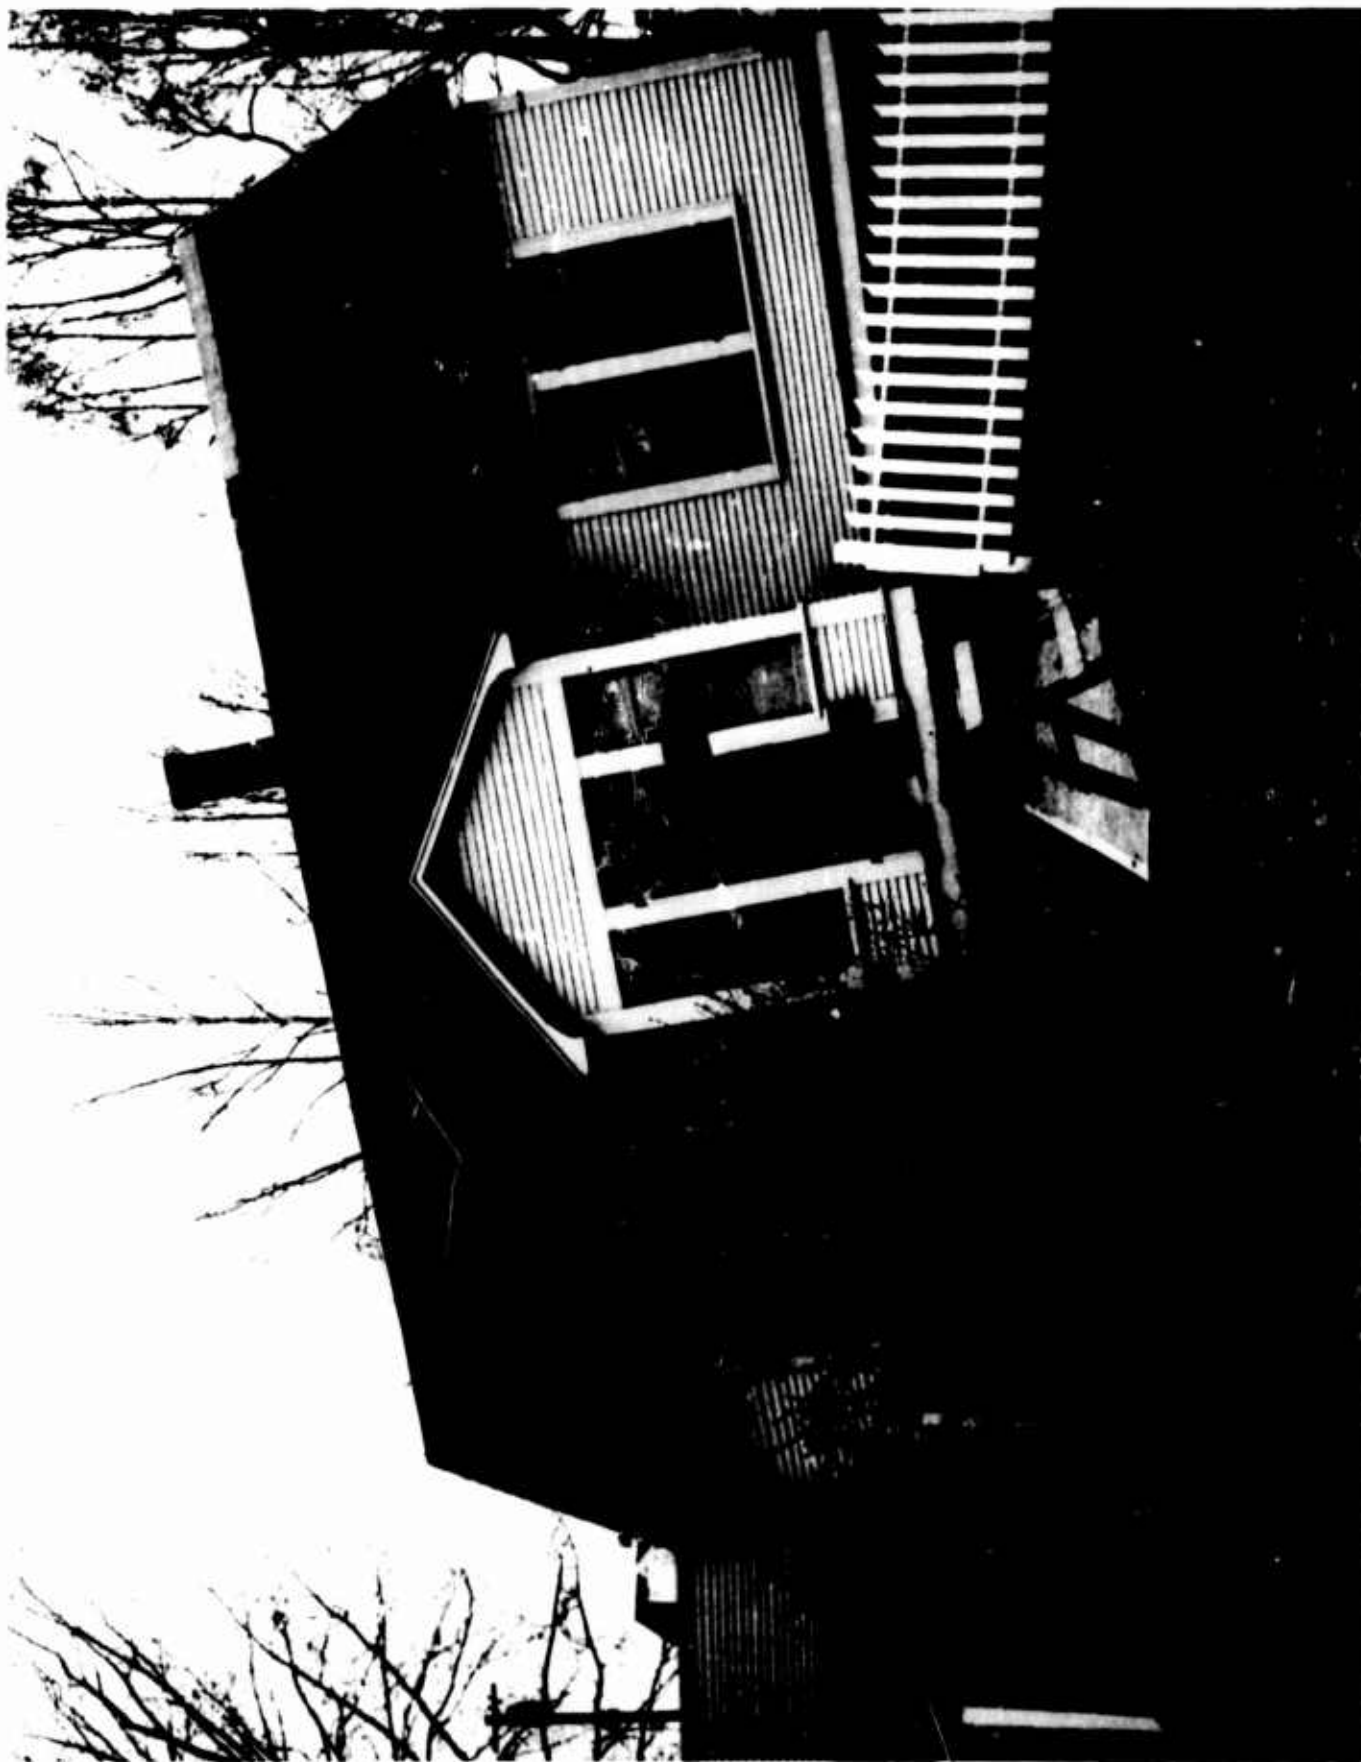
Figure 85. L Street Slide (Residence at Fifth Avenue and K Street)

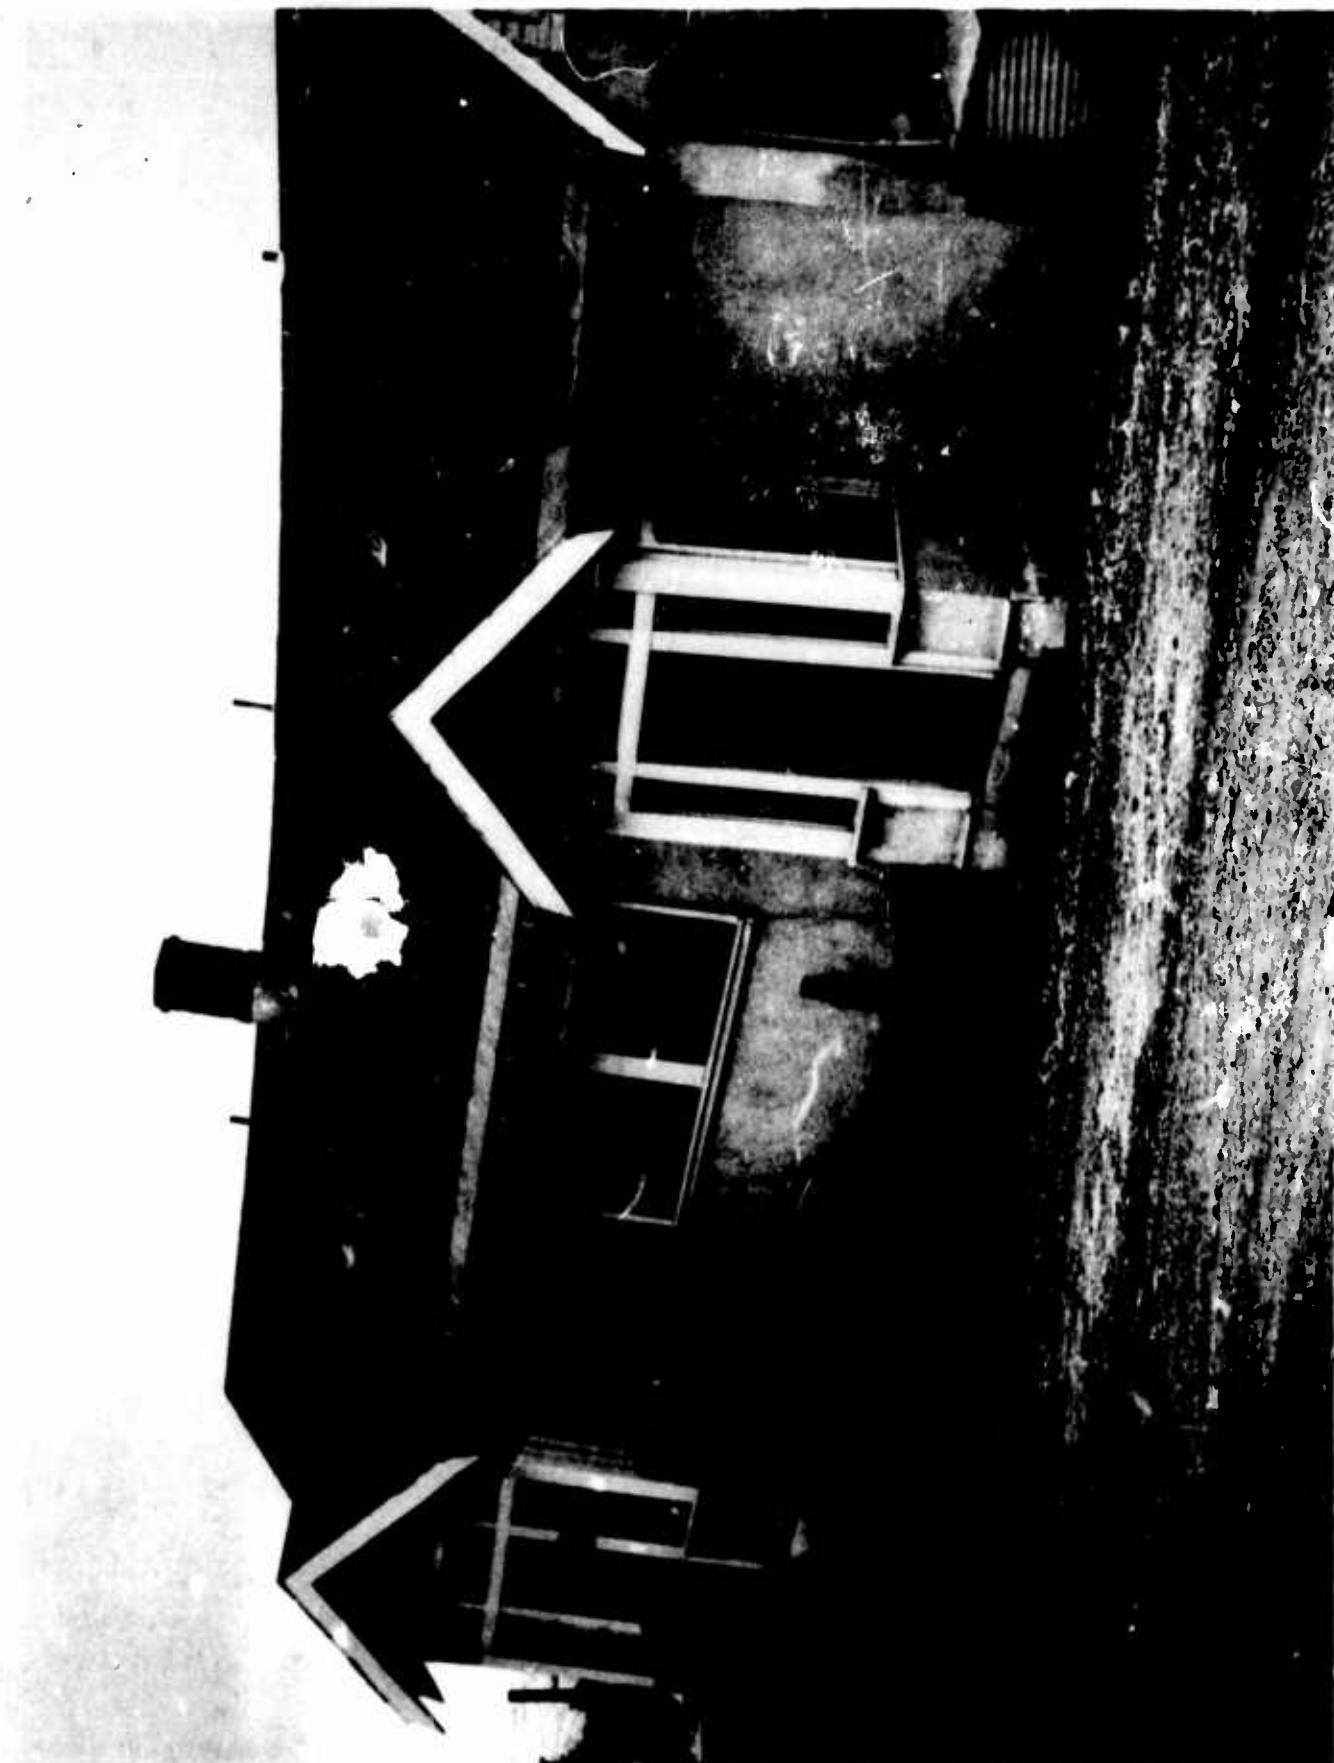
Figure 86. L Street Slide (Residence at Fifth Avenue and K Street)

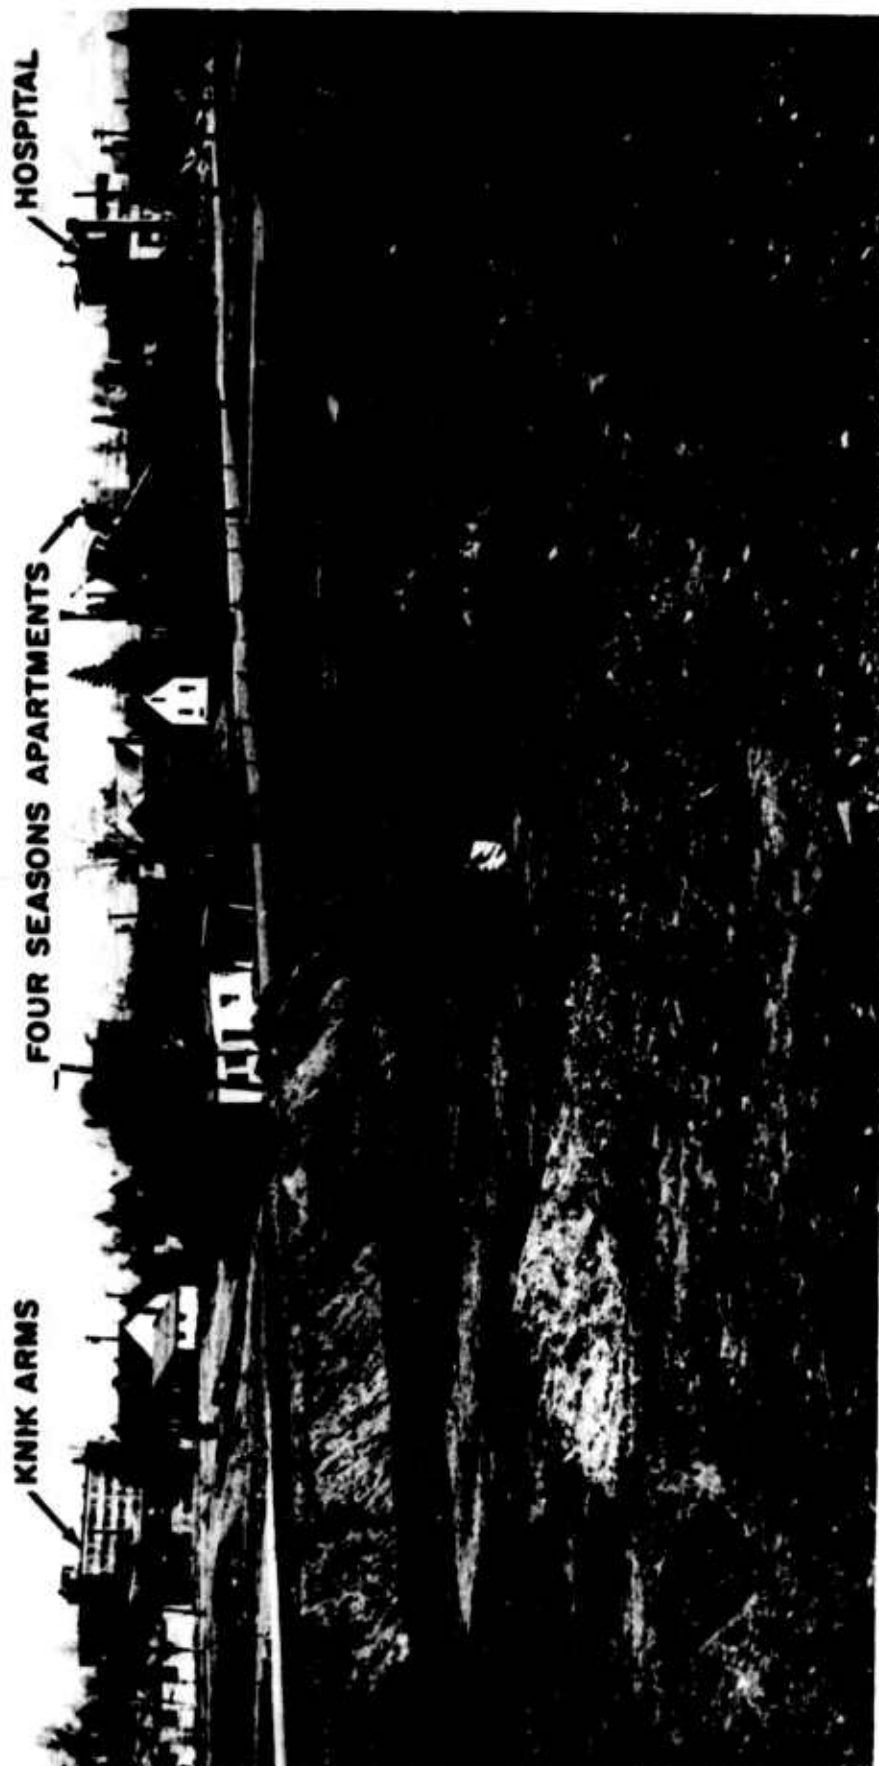
Figure 90. L Street Slide (The graben transversing a city park)

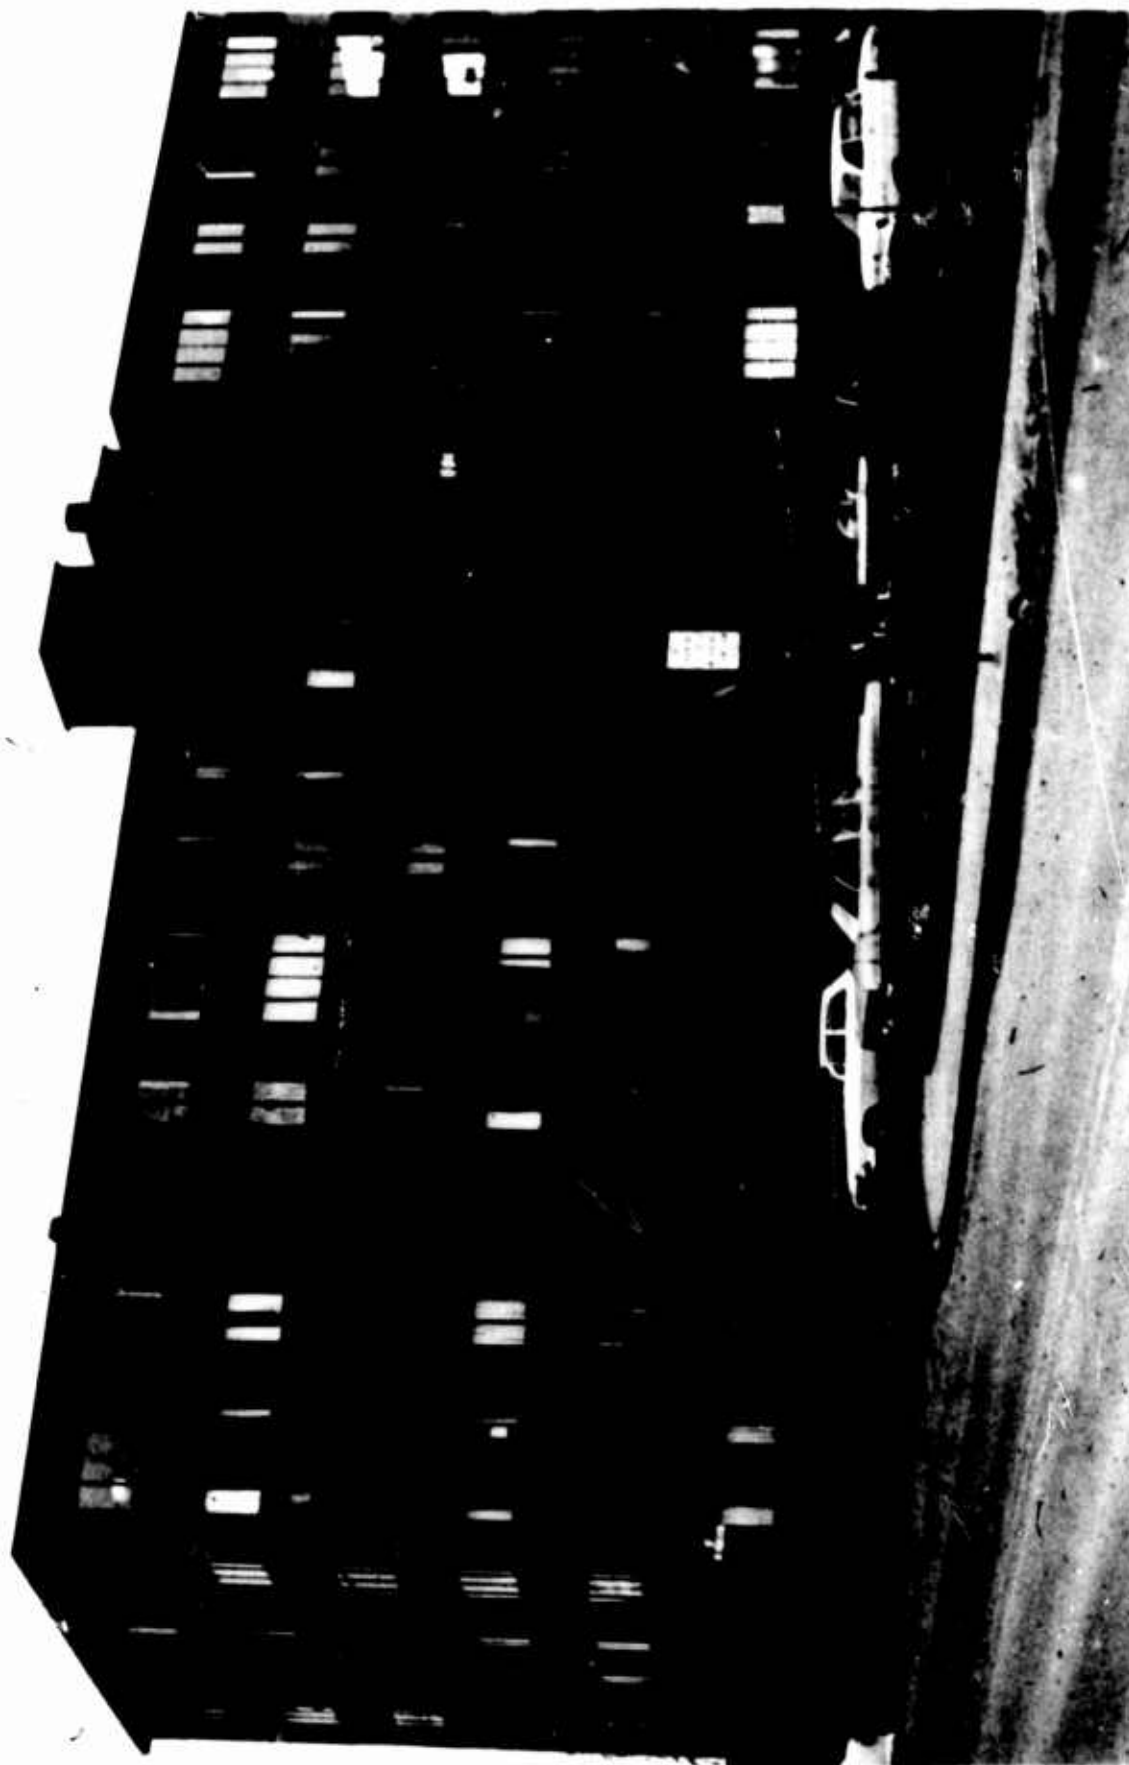
Figure 91. L Street Slide (Knik Arms, a six-story apartment building that moved 11 feet without major damage)

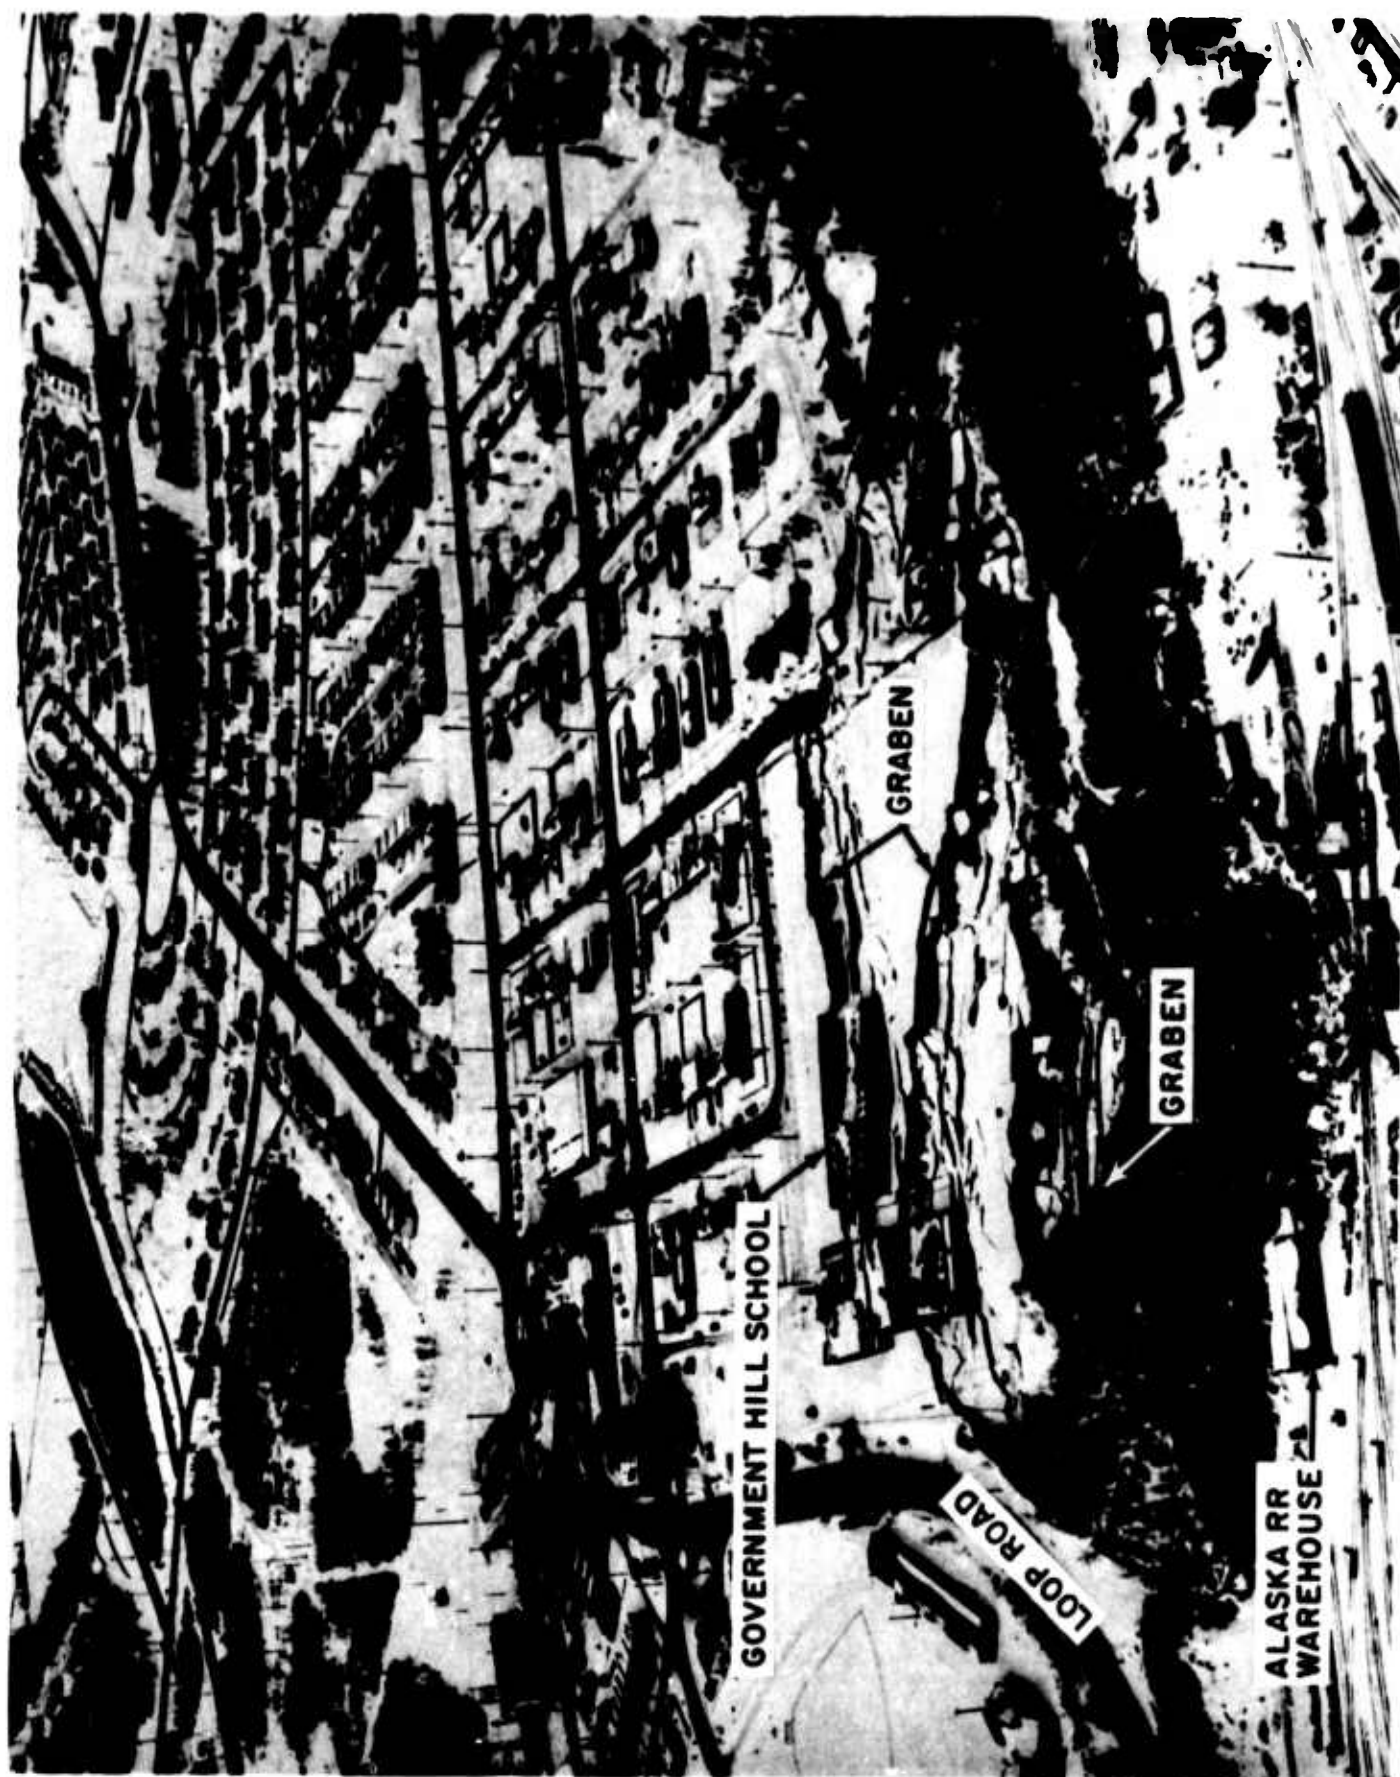
Figure 96. Government Hill Slide (Aerial view of the slide area)

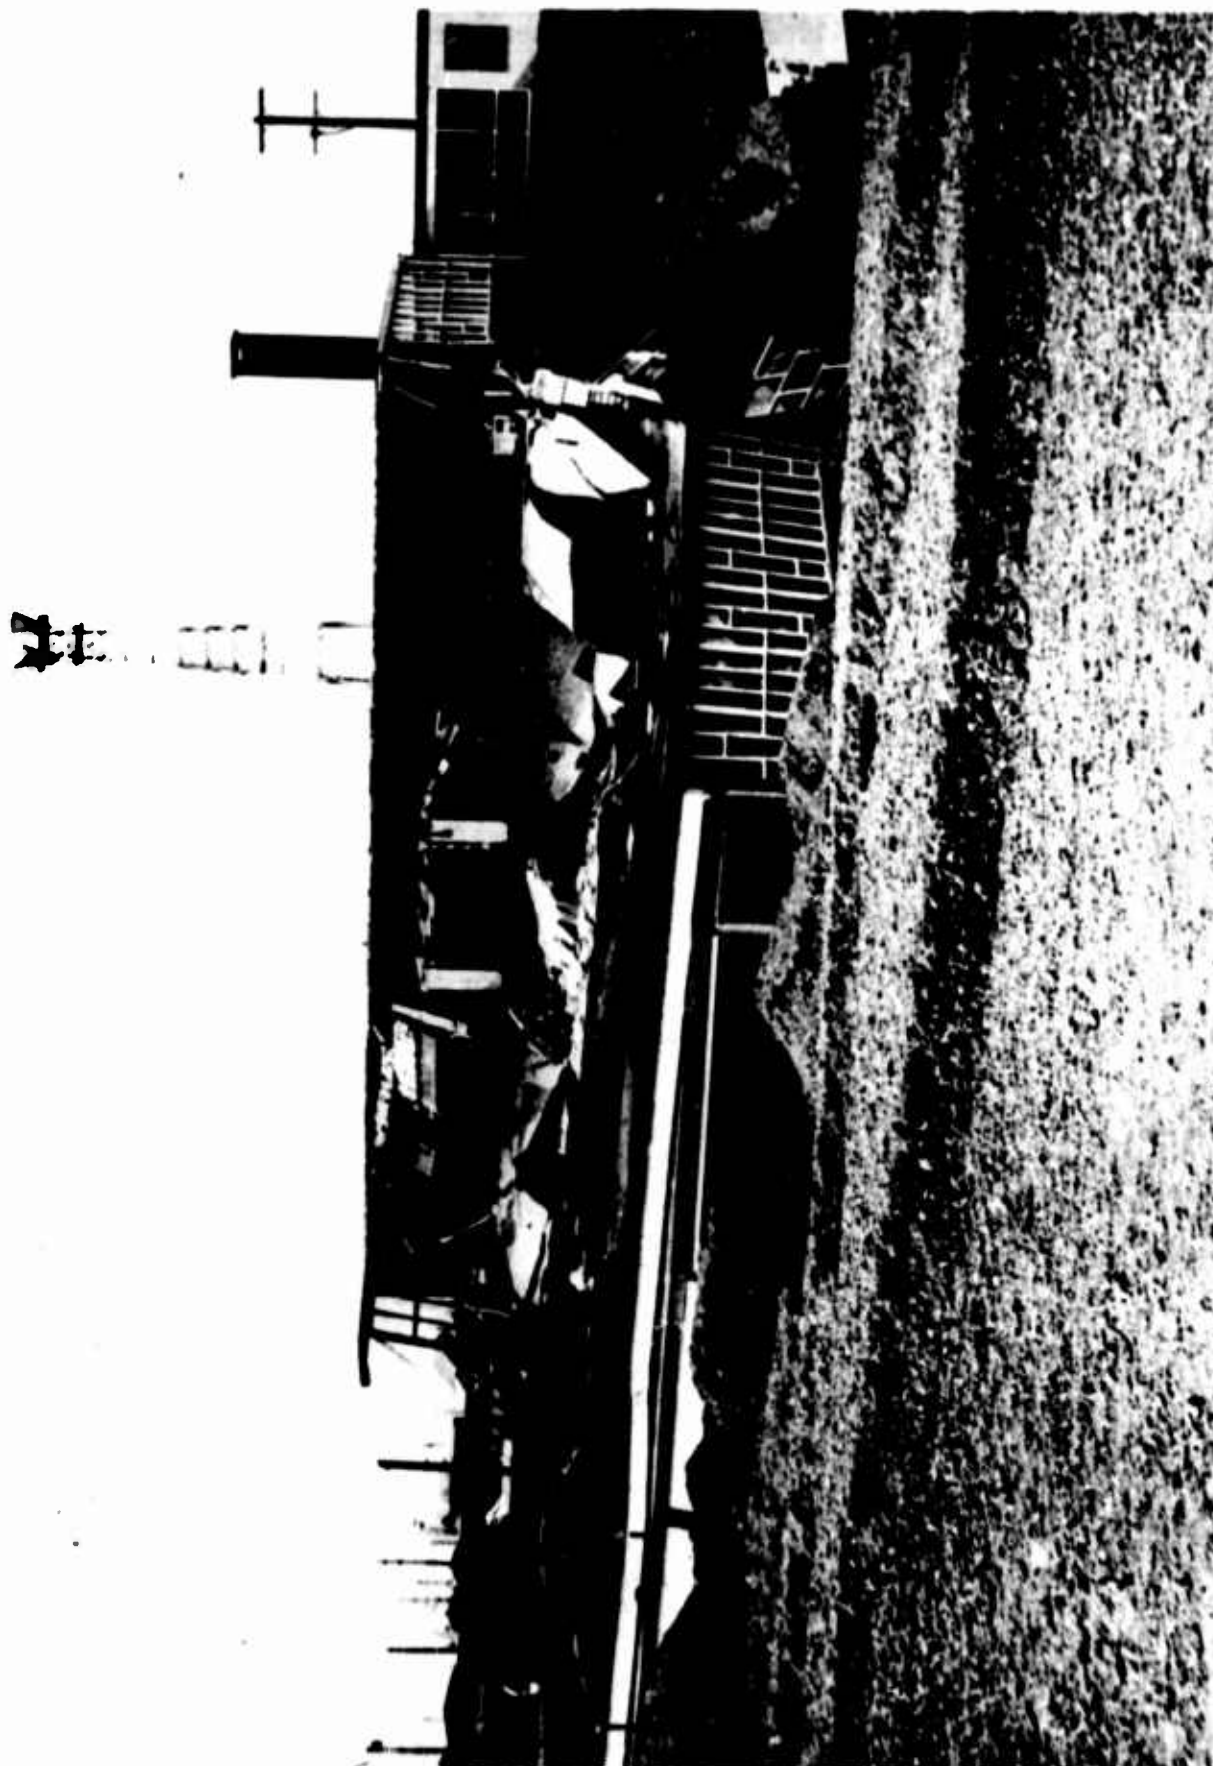
Figure 98. Government Hill Slide (North-south wing of the Government Hill school)

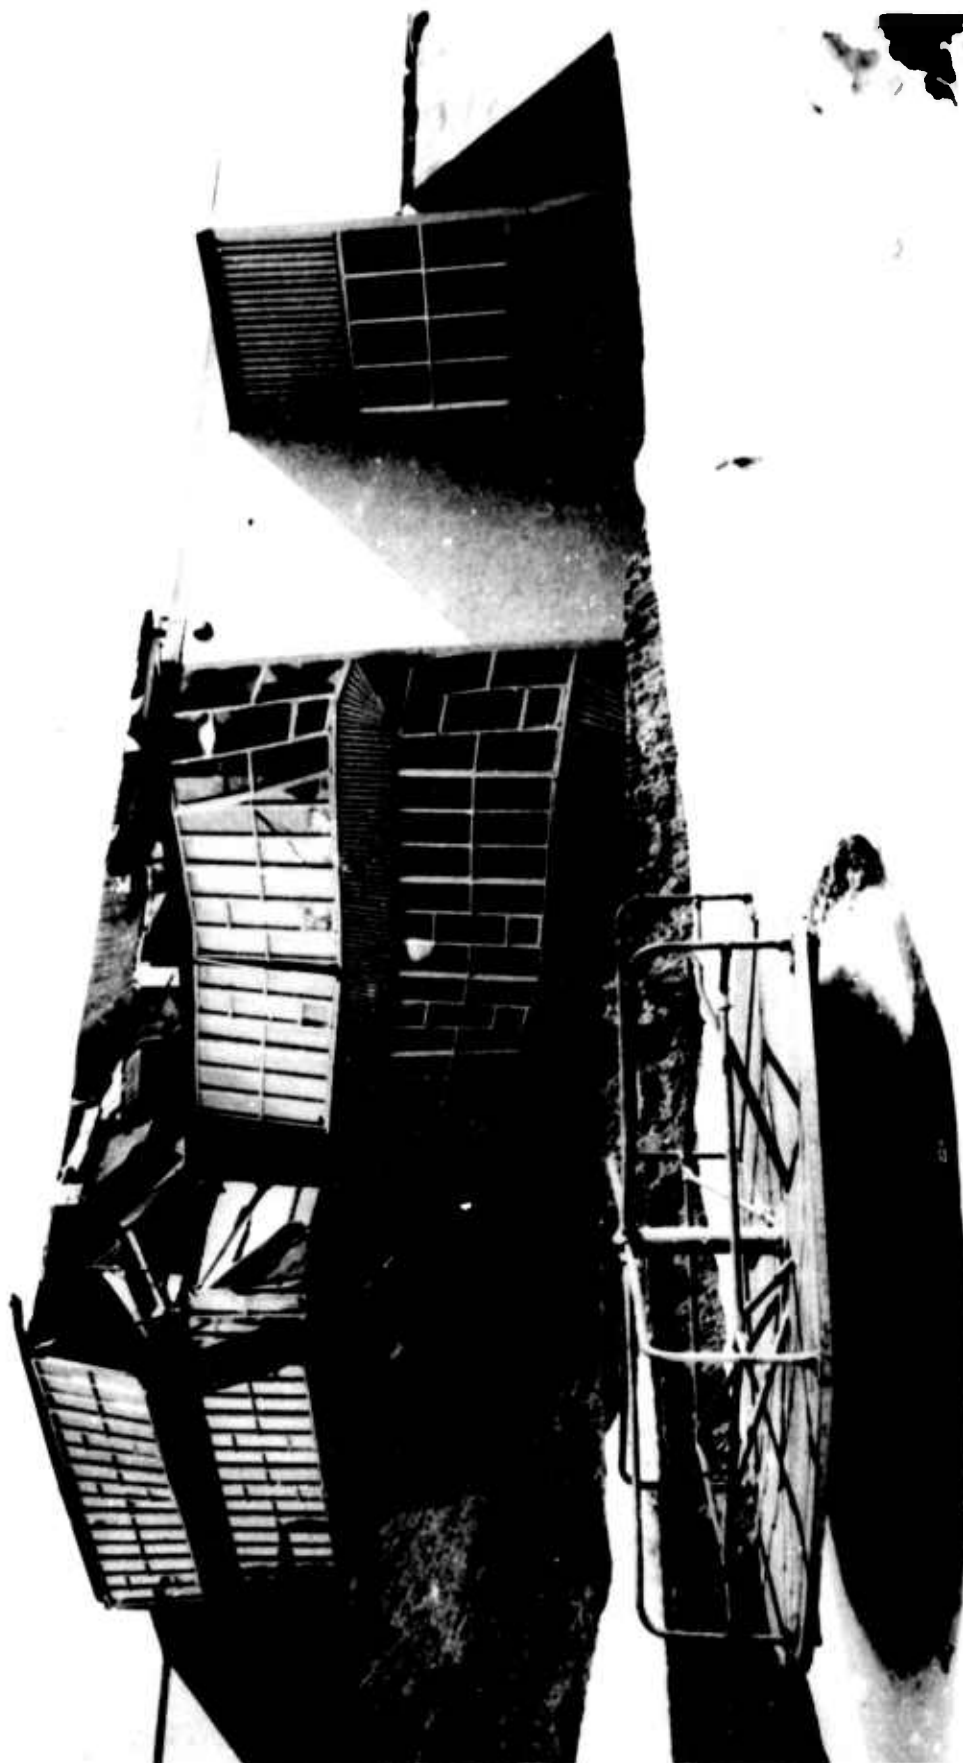
Figure 99. Government Hill Slide (North-south wing of the Government Hill school)
